IOWA STATE UNIVERSITY

MUNICIPAL SEPARATE STORM SEWER SYSTEM  
2016 ANNUAL REPORT

Permit Number 85-03-0-04

March 2016

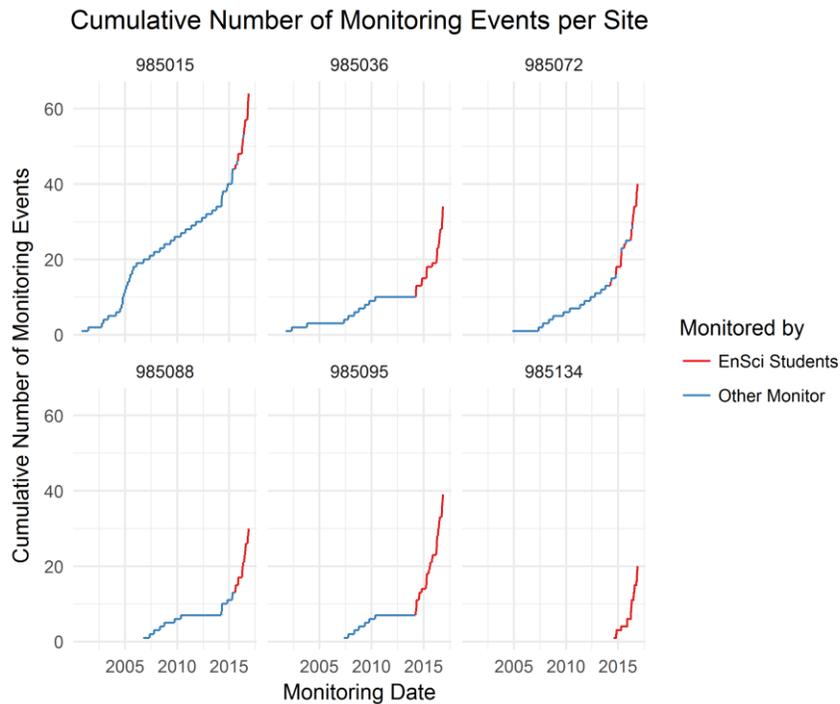
Figure 1: Cumulative number of monitoring events by site. EnSci students have more than doubled the amount of data available for campus streams.

As of this report, EnSci students had completed 133 monitoring events across their six sites in just 3 monitoring years (Table 1), more than doubling the amount of data available for water quality across campus (Figure 1). Data generated by EnSci students are combined with any data collected before the EnSci project began in Spring 2014, and used to better understand the ISU campus' impact on water quality.

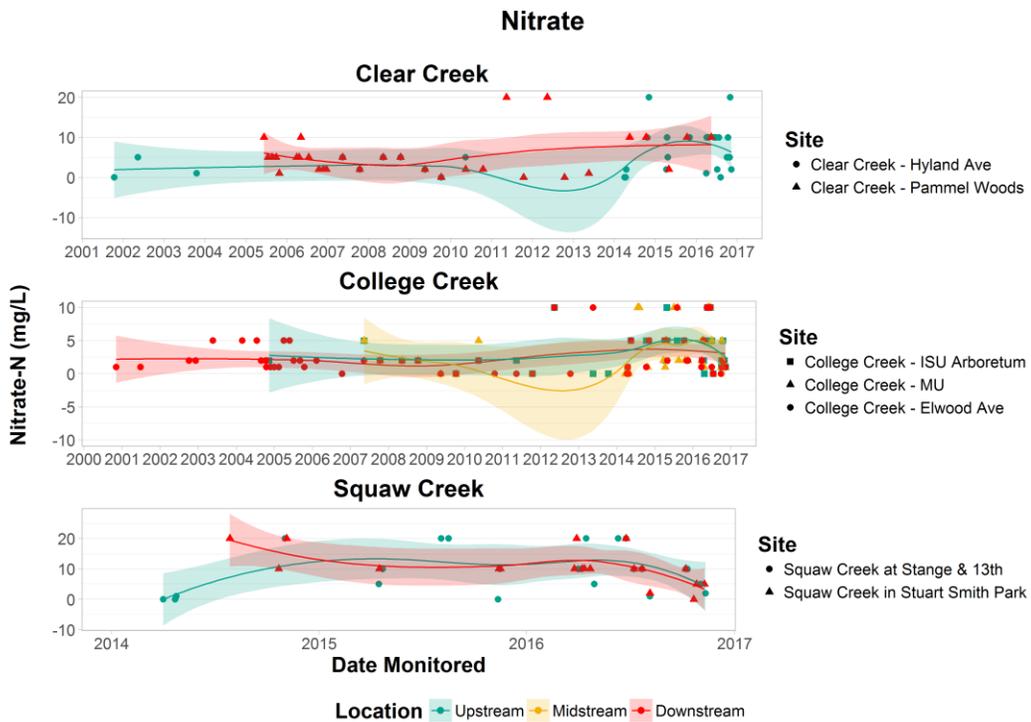
Figure 2: Nitrate results across all seven stream sites included in the analysis of campus water quality. Smooths use Loess regression.

Students collect a wide range of water quality data. The parameters which are most crucial to stream health are reported (Table 2). Nitrate (Figure 2) and phosphate (Figure 3) are key drivers of eutrophication in freshwater systems, and are therefore especially important to consider. Chloride is a useful conservative tracer of anthropogenic inputs (Figure 4). It is typically derived from road or sidewalk salt applications. Chloride itself is harmless to aquatic life, though the sodium that accompanies it can be stressful at high concentrations. It is not biologically active, and so changes in amount upstream to downstream are more easily quantified. Dissolved oxygen is crucial for aquatic life (Figure 5). Fish and invertebrates must have adequate dissolved oxygen to survive, and low levels can cause stress and even death. Aquatic plants require dissolved oxygen at night for respiration. Low levels of dissolved oxygen can be an indicator of eutrophication when accompanied by other markers of high nutrient loads. Transparency is a measure of particulate matter in the water column. This matter may be organic (algae, etc.) or inorganic (soils). Low transparency can be an indicator of high sediment loading to streams caused by erosion of streambanks or uplands, or from material washing in from parking lots or construction sites. High loads of particulate matter can suffocate fish and invertebrates, bury fish nests, and shade the leaves of aquatic plants.

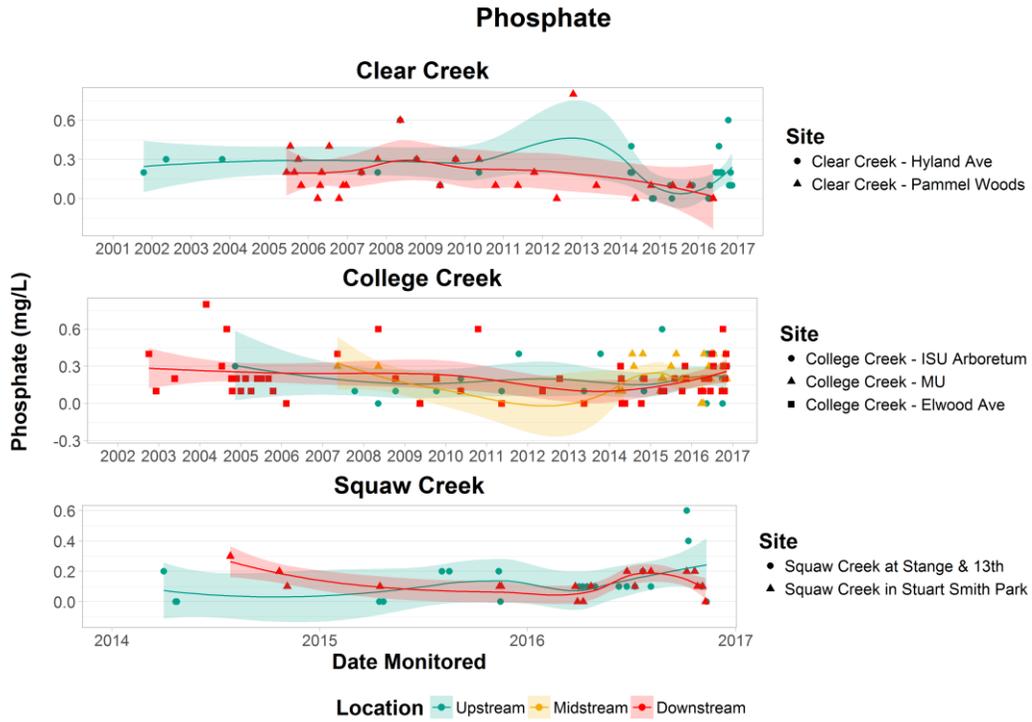
Figure 3: Phosphate results across all seven stream sites included in the analysis of campus water quality. Smooths use Loess regression.

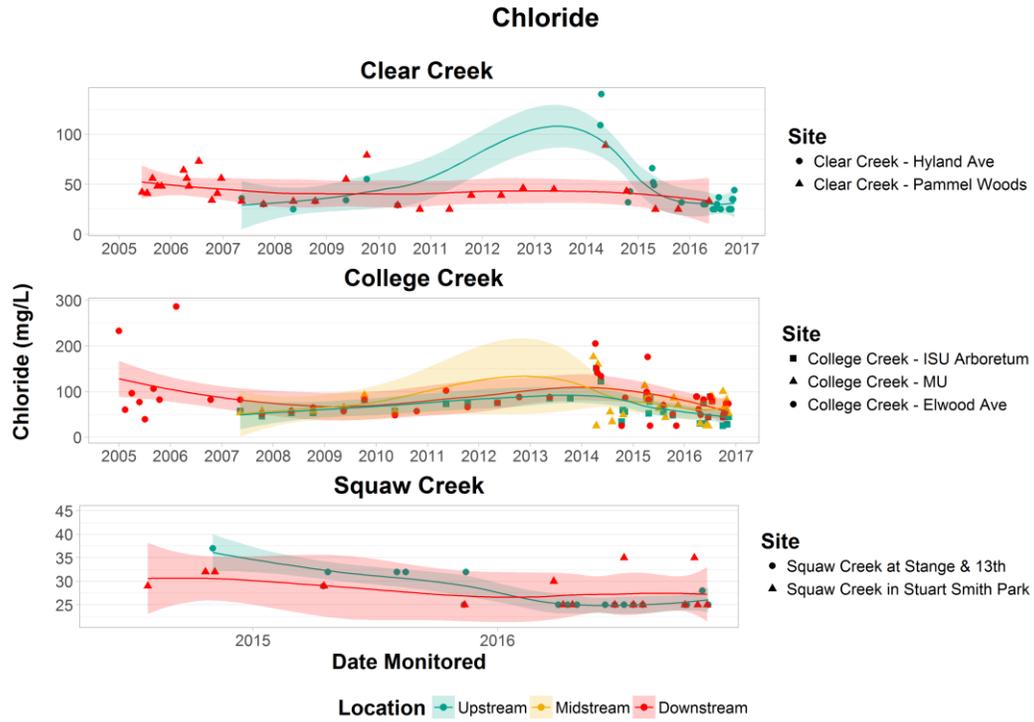
Figure 4: Chloride results across all seven stream sites included in the analysis of campus water quality. Smooths use Loess regression.

Differences in chloride are no longer significant at the  $\alpha = 0.05$  level after adjustment for multiple comparison, meaning that inputs of road and sidewalk salt do not appear to be having a major impact on College Creek at this time.

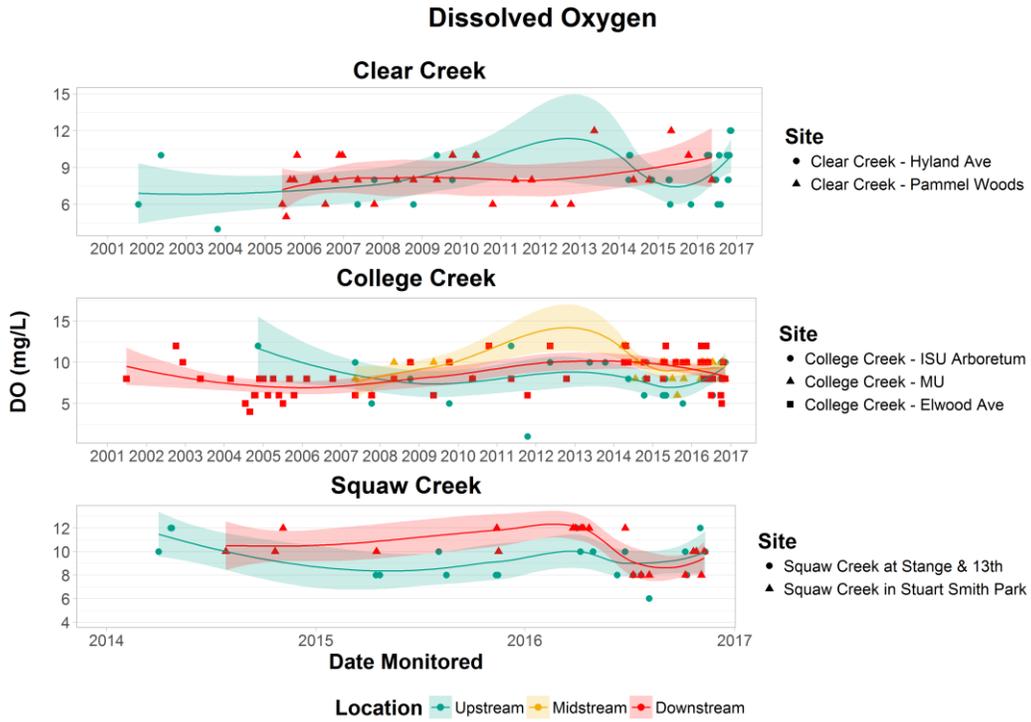
Figure 5: Dissolved oxygen results across all seven stream sites included in the analysis of campus water quality. Smooths use Loess regression.

After adjustment for multiple comparisons, the site pair Clear Creek at ISU Arboretum (upstream) and Clear Creek at Ash Ave (midstream) retain an indication of significant difference ( $p = 0.01669$ ) in dissolved oxygen levels. On average, dissolved oxygen is 1.2 mg/L lower at the Ash Ave site versus the Arboretum

site. This is likely because Clear Creek runs underground beginning at the intersection Lincoln Way and Welch Ave, and only coming back above ground a few meters upstream of the site. Oxygen levels drop slightly in that time, but not enough to be a cause for alarm. Dissolved oxygen levels fully recover by the time the stream reaches the Elwood Ave monitoring location.

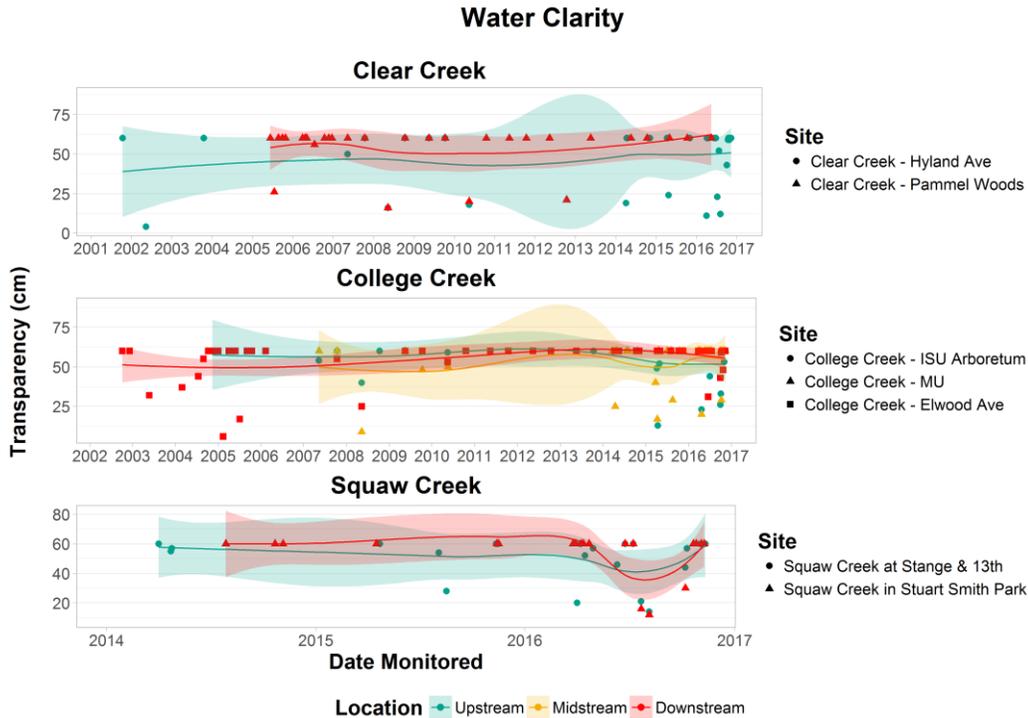
Figure 6: Water clarity results across all seven stream sites included in the analysis of campus water quality. Smooths use Loess regression.

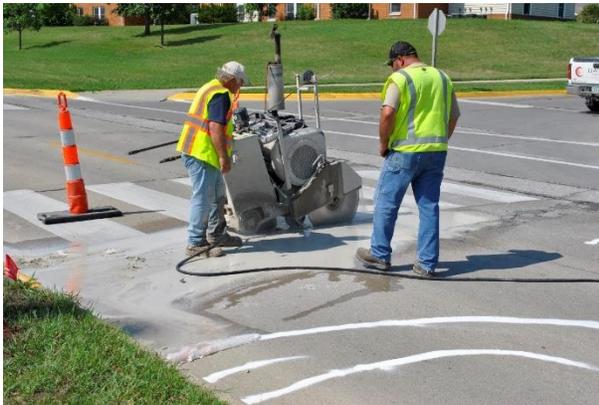
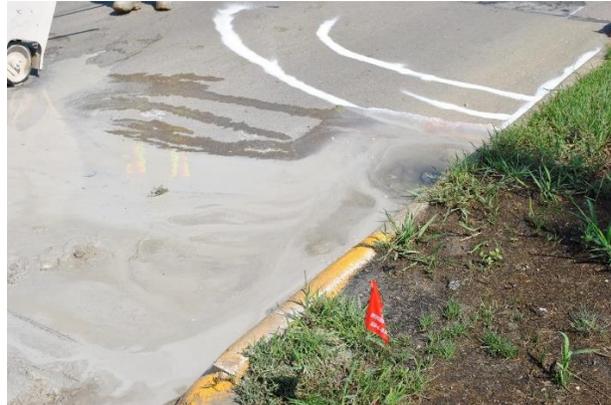
Iowa State projects involving concrete cutting incorporated the practice of utilizing a super absorbent preventing concrete slurry from reaching storm drain intakes.

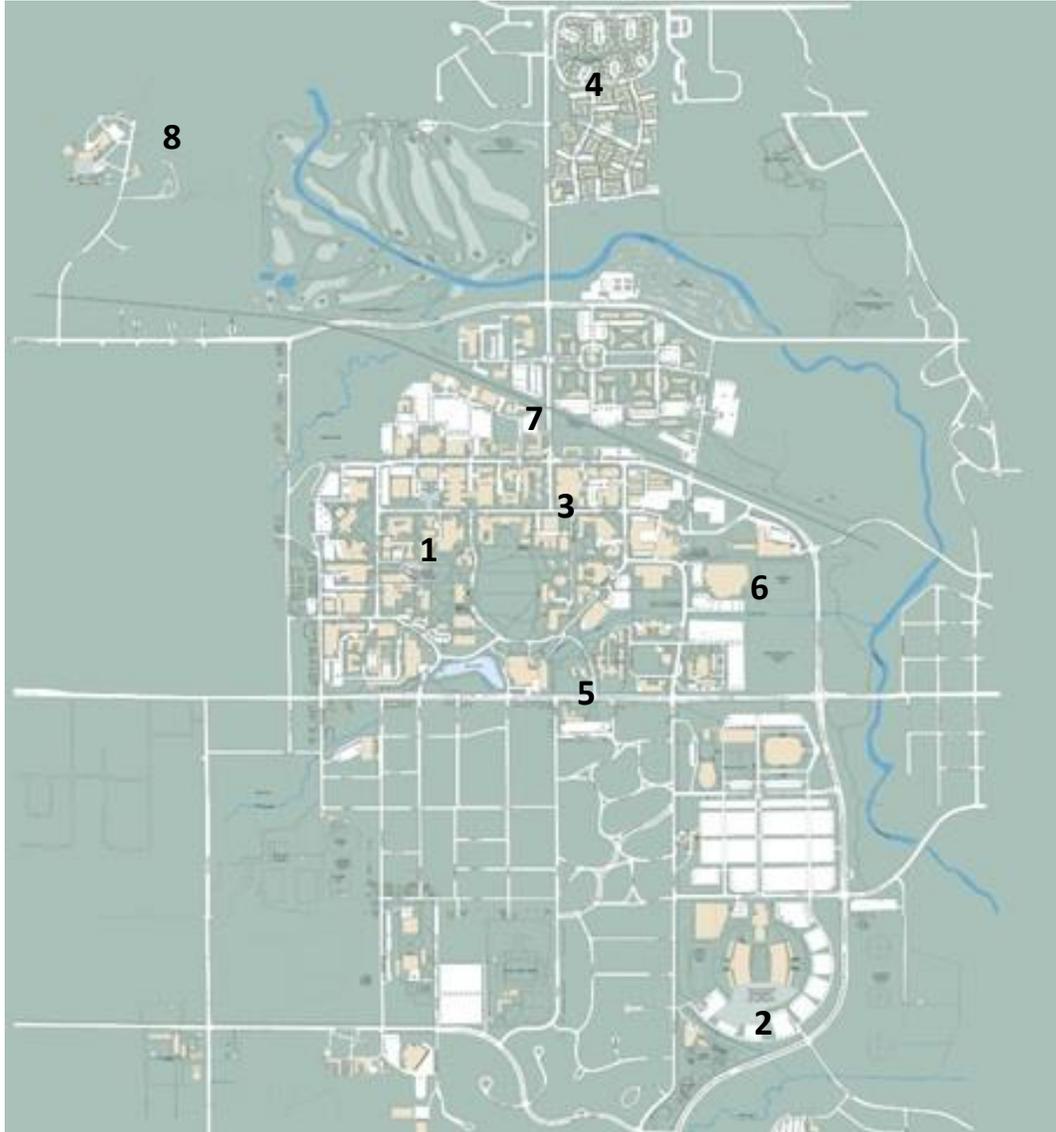
1) Marston Hall Renovations	IA-25789-25540
2) Jack Trice Stadium Green Space	IA-28751-28483
3) Bessey Hall Improvements and Addition	IA-28244-27992
4) University Village Patios	IA-26981-26719
5) Buchanan Residence Bldg. 2	IA-27005-26737
6) Recreation Field College Creek Pedestrian Crossing	IA-28640-28374
7) Advanced Teaching Research Bldg.	IA-28103-27854
8) Spangler Geotechnical Laboratory Bldg. Demolition	IA-30014-29746
